Cardiovascular Imaging In-a-Month

Valsalva 洞動脈瘤破裂術後例で心内 腫瘤を疑われた 57 歳男性

A 57-Year-Old Man With Intra-Cardiac Tumor Occurring After Operation for Rupture of Valsalva Sinus

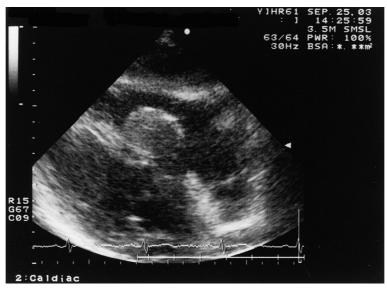
Fig. 1 Two-dimensional echocardiogram showing a large round mass in the right ventricle just below the tricuspid valve

現病歴: 1972年, Valsalva 洞動脈瘤破裂(type A)と診断され, A大学病院で手術を施行された.その後, とくに自覚症状はなかったが,検診で心電図異常を指摘され, B病院を受診し,心エコー図検査により右室内に腫瘤影を認めたため,精査目的で当院を紹介受診となった.来院時の理学的所見では血圧136/68 mmHg,脈拍65/min,整.胸骨正中に手術痕あり.胸骨左縁においてLevine 度の収縮中期雑音を聴取した.心電図は1,2でQSを呈し,左室高電位とT波の平低化を認めた.心胸郭比は46%で,肺野にうっ血所見などは認められなかった.B病院で施行された心エコー図検査の写真をFig.1に示す.

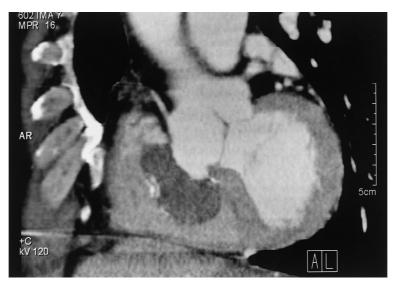
Fig. 2 Multi-slice computed tomography scan demon-

strating a low density mass in the right ventricle The mass connecting with the Valsalva sinus was filled with thrombus.

当院で経胸壁および経食道心エコー図検査を施行したところ,腫瘤は右 Valsalva 洞から連続しており,最大径約 42 × 40 mmで,左室の収縮に伴い可動性を有していた.腫瘤内部はほぼ均一なエコー輝度を呈し,三尖弁を通過する拡張早期血流は腫瘤の圧排により 87 cm/sec と加速していた.腫瘤から心内腔にシャントする血流は認められず,大動脈弁逆流も認められなかった.腫瘤と右室壁の連続性がはっきりしないため,マルチスライスコンピューター断層撮影を施行した(Fig. 2).右室内に突出した腫瘤は辺縁に石灰化が認められ,右室壁との連続性はなく,右Valsalva 洞のみに接していた.以上の所見より右Valsalva 洞動脈瘤が右室に突出し,内部に血栓が生じたものと診断した.
